Manhole Inspection Summary

Manhole # S43K__030MH

Insp Date: **6/4/08 9:37 AM**

Location Address: **701 broadway st**

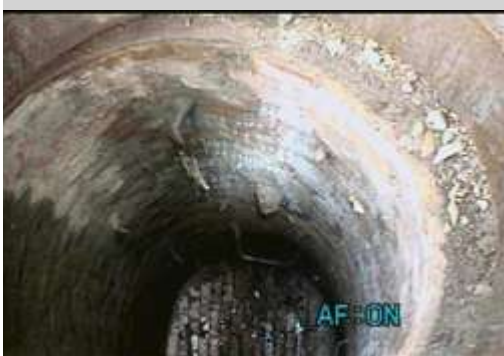
Defect 2

Count: **6** Missing: **4** ☒ **Corroded**

missing/corroded steps

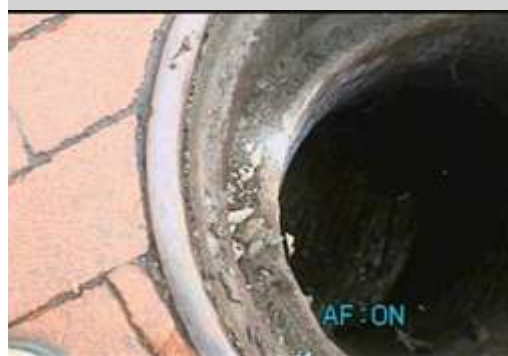
Defect 1

Offset: **3** (in.)

offset

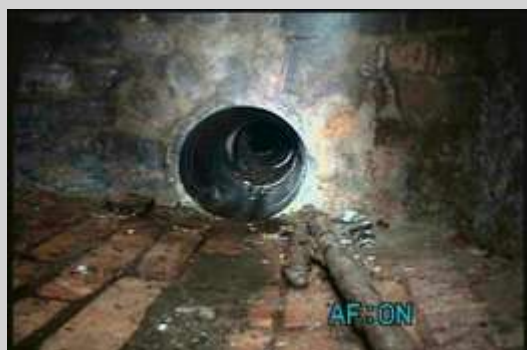
12 O'Clock Outflow

8 in. Circular Gravity Sewer
Pipe Out @ 12 O'Clock

Pipe Material: **Clay** ☐ Pipe Lined

Invert Depth: **10.50** (ft.) Flow Characteristics: **None**

Deposits: ☒ None ☐ Mud ☐ Sludge ☐ Debris ☐ Grease

Infiltration: **None** Pipe Seal Cond: **Unknown**
